PROJECT REPORT

Commercial Roof Restoration - Sydney Fish Markets

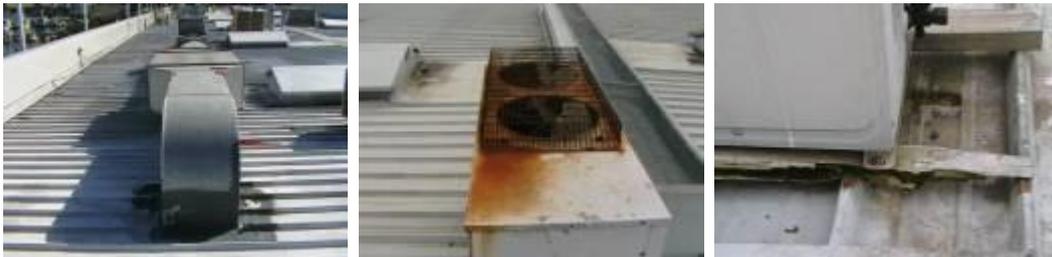
Ninety smoke stacks on the roof proved to be a ready source of numerous leaks in particular rain/wind conditions. These were sealed byway of rapid curing class 111 latex membrane (**Acrythane**) impregnated with polypropylene fibres prior to been coated with the top coat membranes and urethane sealants.

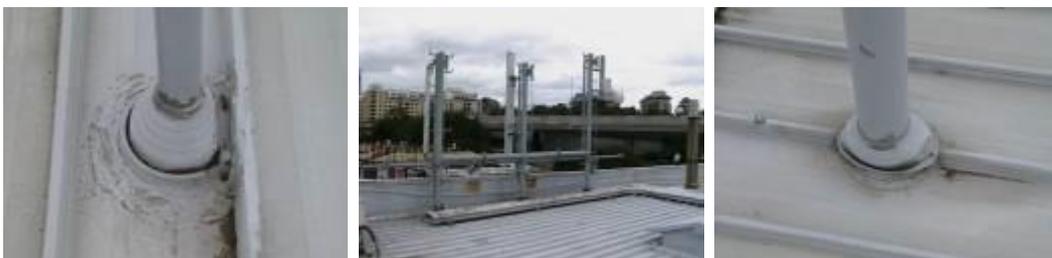
Numerous mobile phone towers were repaired with new flashings and dektites as the existing ones had perished from the continued exposure to water and bird droppings.

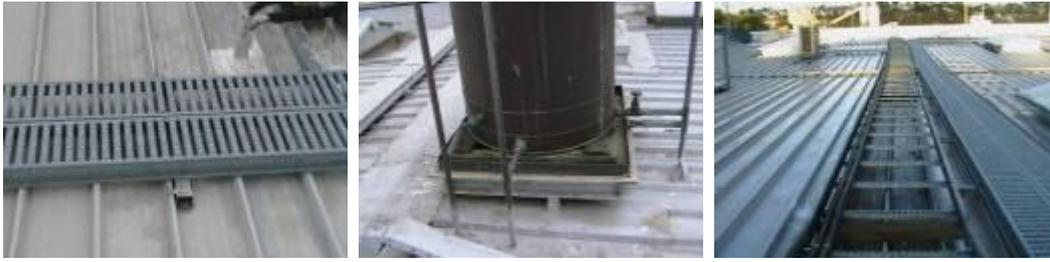
Multiple air-conditioning units of all sizes and cable trays, mostly supported on wooden supports that invariably had rotted through. New aluminium supports were installed under all equipment after the extensive rust in these areas was treated.

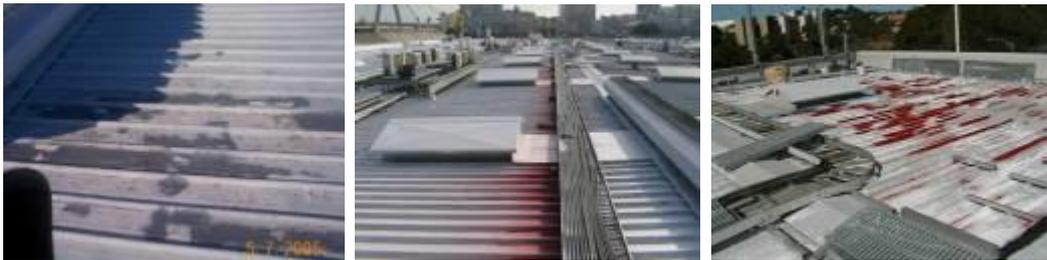
A combination of airborne pollutants (60,000* cars per day pass directly over the fish market building) from motor vehicles, two cement works, salt laden water from the ocean, oils from food exhaust vents and extreme build up of condensation under cable trays created a very hostile environment which is particularly conducive to corrosion.
