PROJECT REPORT

Commercial Roof Restoration - Sydney Fish Markets

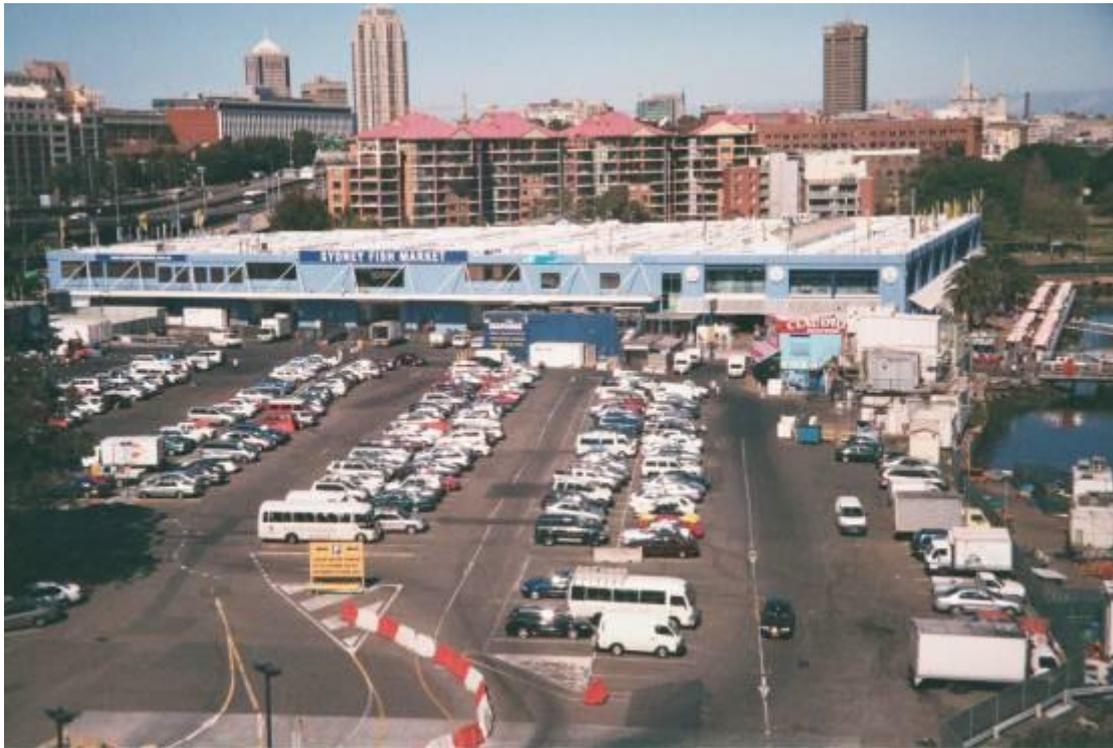
The Sydney Fish Market roof is 10,500 square metres in size (14,500 square metres including the sheeting profile). The roof comprised of eight individual roofs separated by long and shallow box gutters. The roof was in a bad state of repair with numerous significant leaks and a lot of corrosion and holes.

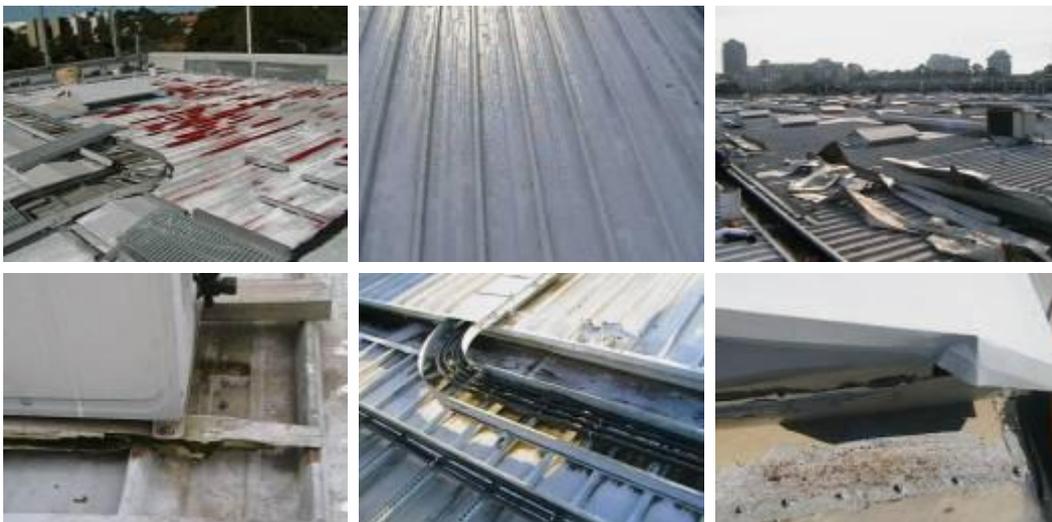
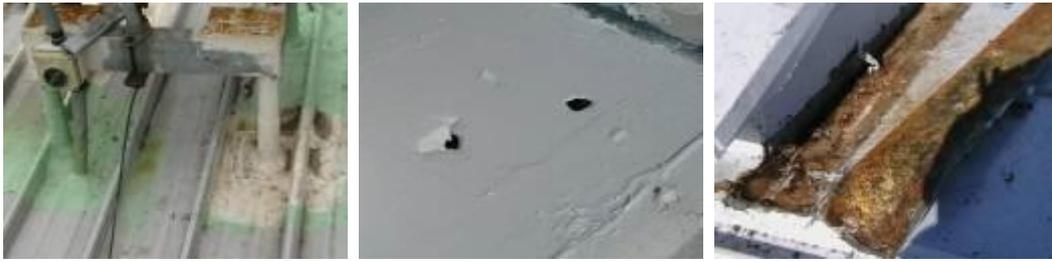
The roof was over 40 years old, it has been previously patched and membrane coated. All previous repairs had not led to a long-term leak free roof with absence of rusting and severe sheeting degradation. The previous membrane extensively bubbled and was peeling off.

The low roof pitch and extremely shallow box gutters have been incapable of removing the water on the roof quickly enough during heavy rain periods and this aspect caused additional damage and leaks. (Due to a stramit panelling system below roofline leaks were difficult to locate)

The system specified by **Cool & Dry Roofing** saved the client in excess of \$1.5m when compared to a total roof replacement cost. There was also no interruption to the operation of the Fish Market during the 5-month project.

The system entailed repairing all roof sheeting fixtures and fittings, modifying the inadequate box gutters to cope with severe storm conditions, covering the roof with a thick urethane acrylic UV stable trafficable membrane and finally, applying a top coat of a **Solarproof** heat re-radiating membrane to stop nearly all heat from entering the roof / facility.

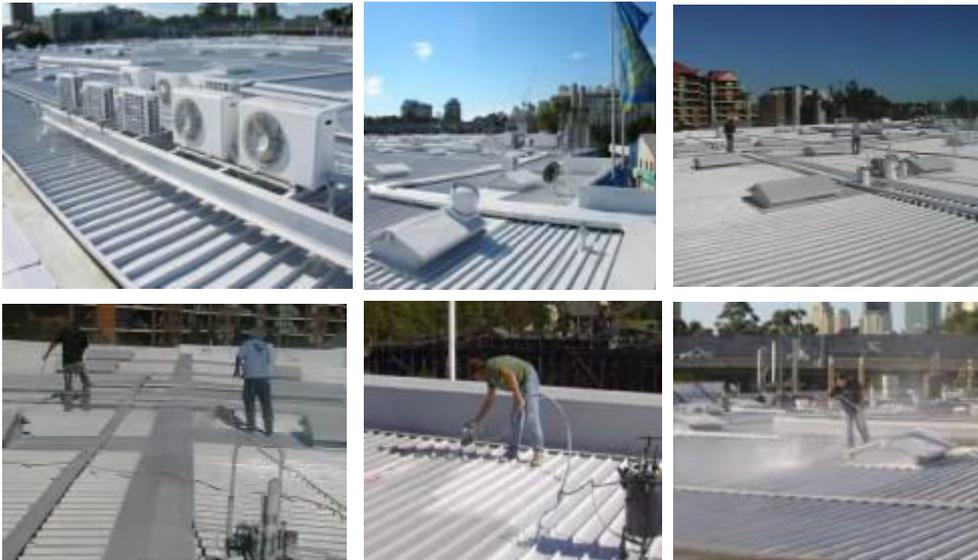
An environmentally friendly corrosion treatment (**Metalreat**) was applied around all areas where bird droppings were causing corrosion. **Metalreat** was chosen to prevent the acid in the droppings from rotting the metal roofing and gutters.

A bird barrier was installed on all box gutters that also acts to stop leaves from causing blockages in the downpipes.
